COST Action TU0901 – Building acoustics throughout Europe. Volume 2: Housing and construction types country by country

**COST Action TU0901:
Integrating and Harmonizing Sound Insulation Aspects
in Sustainable Urban Housing Constructions**

Building acoustics throughout Europe Volume 2: Housing and construction types country by country

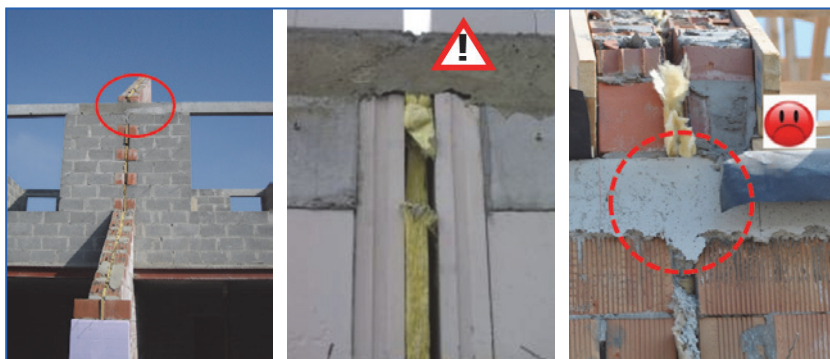
Figure 2.7. Hard connections (continuous floors, concrete beams but even small metal ties can largely reduce the sound insulation; the party wall loses its acoustic double wall behaviour and extra flanking transmission will occur.

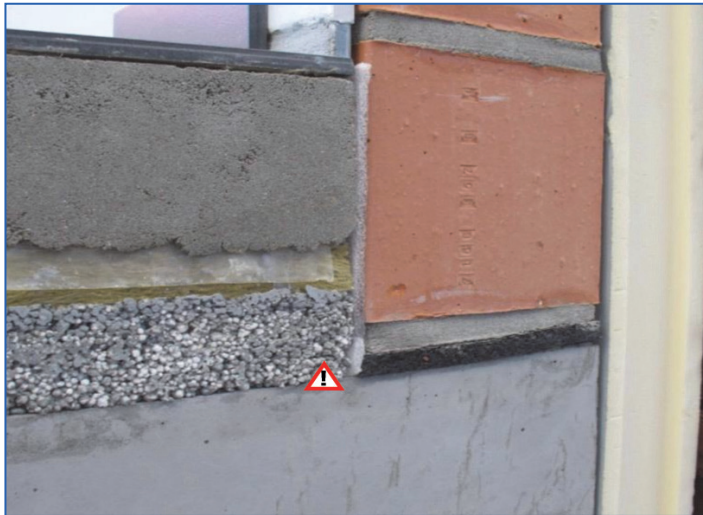
Figure 2.12. Detail of concrete slab with floating floor and acoustic strip (Sonic strip, Wienerberger – CDM). It is important to put a border resilient strip before executing the levelling screed to avoid a hard contact between the concrete slab and the brick wall!

- A great quantity of mortar bridges connecting the brick wall and the floor slab can deteriorate the sound insulation;
- When no elastic border strip is placed against the brick wall before pouring the levelling screed, then this latter can form a “vibration bridge” between the brick wall and the concrete slab, deteriorating seriously the sound insulation (see Figure 2.12);

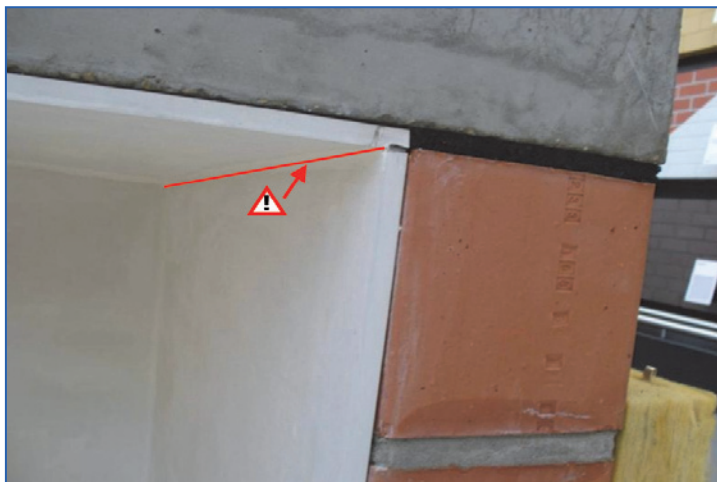
Figure 2.13. Detail of the acoustic strip below the concrete slab and on top of the wall. It is always important to cut the plaster at the junction between the brick wall and the concrete slab to avoid cracks (different thermal dilatation), but when using acoustic strips, it should be cut completely down to the acoustic strip and filled up with silicones to avoid a “vibration bridge”.

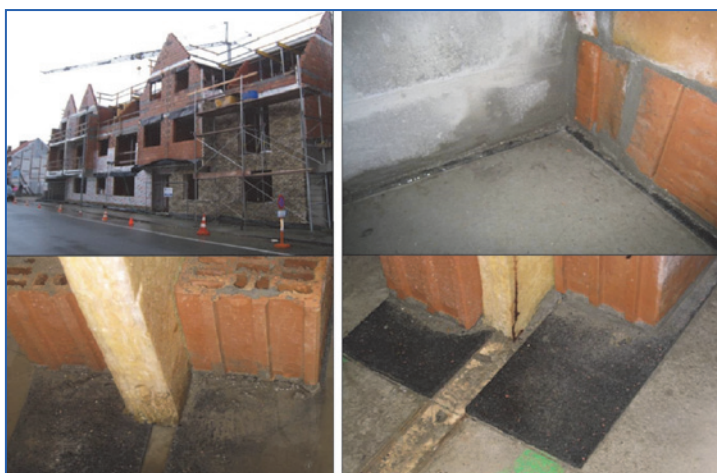
Figure 2.14. Application of acoustic strips below brick walls (party wall below) and concrete blocks (the elevator shaft). The acoustic strips (CDM, Sonic strips) have only a limited deformation (2 mm under the weight of the building, almost no creep in time).

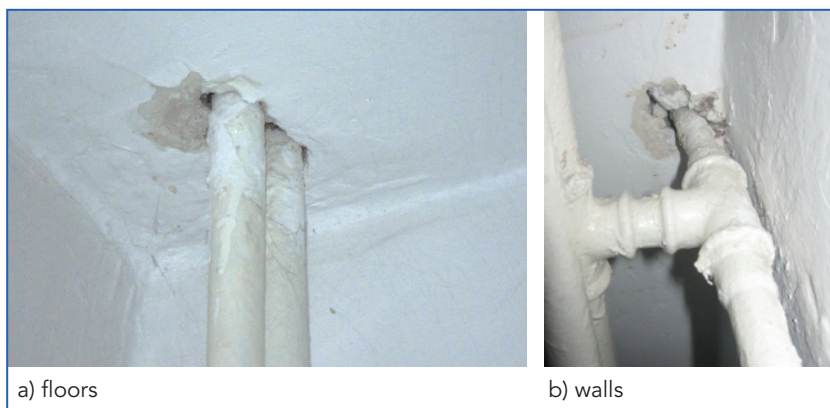
Figure 21.21. Typical errors for cross pipes.
